MHT No. <u>HA-1977</u>

MARYLAND INVENTORY OF HISTORIC BRIDGES HISTORIC BRIDGE INVENTORY MARYLAND STATE HIGHWAY ADMINISTRATION/MARYLAND HISTORICAL TRUST

SHA Bridge No. 12030 Bridge name MD 136 over Big Branch
LOCATION: Street/Road name and number [facility carried] MD 136 (Harkins Road)
City/town Harkins Vicinity X
County Harford
This bridge projects over: Road Railway Water X Land
Ownership: State X County Municipal Other
HISTORIC STATUS: Is the bridge located within a designated historic district? Yes No _X National Register-listed district National Register-determined-eligible district Locally-designated district Other
Name of district
BRIDGE TYPE: Timber Bridge: Beam Bridge: Truss -Covered Trestle Timber-And-Concrete Stone Arch Bridge: Metal Truss Bridge
Movable Bridge: Swing Bascule Single Leaf Bascule Multiple Leaf Vertical Lift Retractile Pontoon
Metal Girder: Rolled Girder: Rolled Girder Concrete Encased Plate Girder: Plate Girder Concrete Encased
Metal Suspension
Metal Arch
Metal Cantilever
Concrete X: Concrete Arch: Concrete Slab: Concrete Beam X: Rigid Frame Other: Type Name:

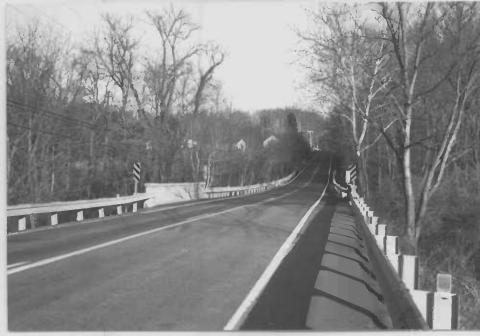
1. HA -1977 2. MD 136 over Big Branch (12.030) 3. Harford Co, MD 4 Caroline Hall 5 3/97 6 MD SHPO 7 south side 8.10/5

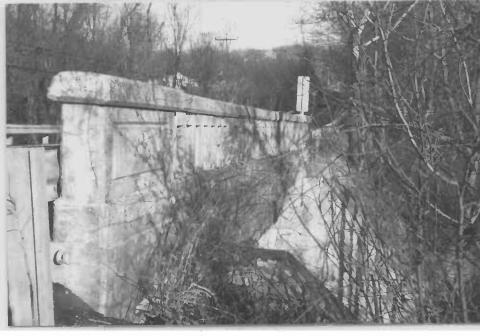
1. HA-1977 2. MD 136 over Big Branch (12030) 3 Harfard Com 4 Caroline Hall 5. 3/97 6 MD SHPO 7. roadway approach 8.2015

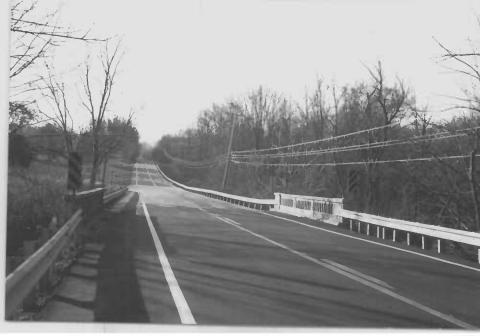
1, HA-1977 2. MD 136 over Big Branch (12030) 3. Harford a, mo 4. Caroline Hall 5.3/97 6. MD SHPO 7. roadway approach

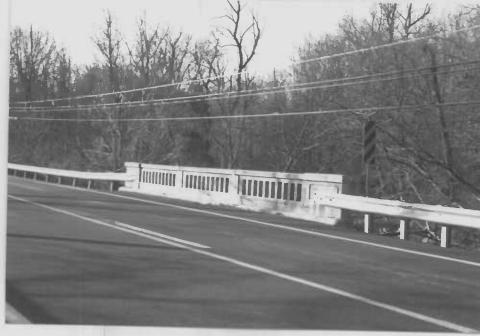
1. HA-1977 2. MD 136 over Big Branch (12030) 3. Harford Co, MO. 4. Caroline Hall 5.3/97 6. MD SHPO 7. north paraget 8.4015

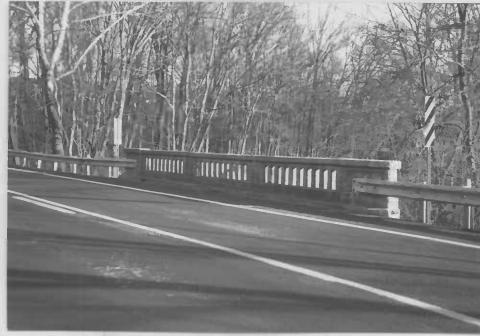
1. HA = 1977 2. MD 136 0 10 Bug Branch (12030) 3. Harford 6, MD 4. Caroline Hall 5 3/97 6 MDSHPD 7, south parapet 8.5015

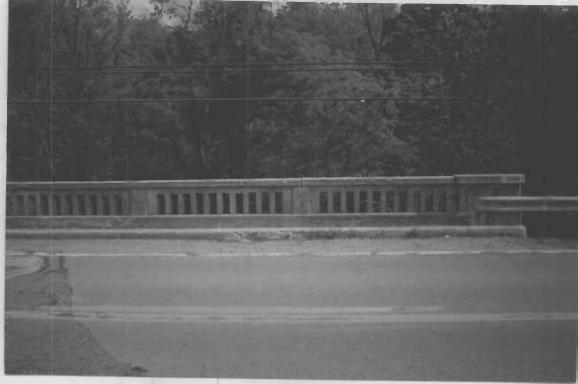
Bridge No. 12030 Dat	te 5/10/93
MD RTE 136 over BIG BI	RANCH
Other (Describe) NORTH F	PARAPET,
EAST	
•	HA-1977
•	
•	
•	
•

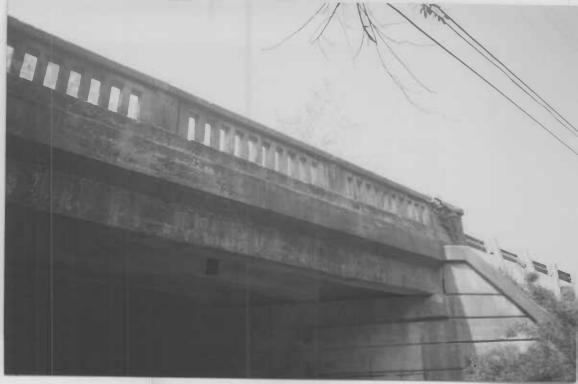
Bridge No. 12030	Date 5/10/93
MDRTE 136 over BK	/
Other (Describe) NOR	TH PARAPET,
WEST SIDE	
•	HA-197
•	
•	
•	
•

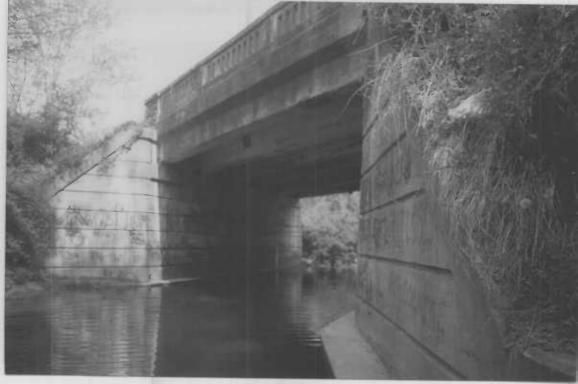
Bridge	No. 17030	Date 5/10/93	_
MDR	TE.136_over_E	BIG BRANCH	_
Other	(Describe)	DERSIDE OF DECK	2
SCUT	<u>H</u>		
•	making aranimatahan	HA-19-	77
•			
•			_
•			_

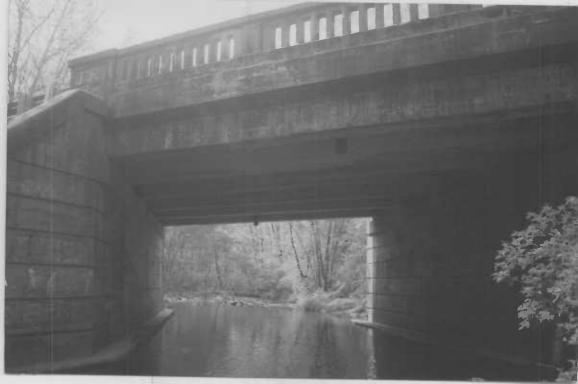
Bridge No. 12030	e 5/10/93	
MD RTE. 136 0	RANCH	
Other (Descri)	SIDE OF DECK,	
NORTH SU		
CLOOK	HA-1977	
0		
0

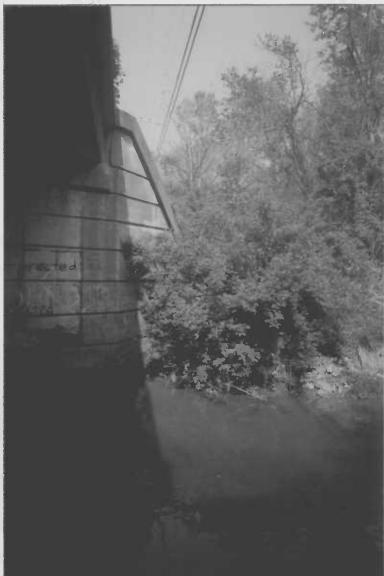
Bridge	No. 17030	_Date_5	10/9	3
	E 136 over BiG			
Other	(Describe) /	· · · <u>V</u>	VING	WALL
•			HA.	-1977
•				
•				
•				
•				
•
